# Appendix J

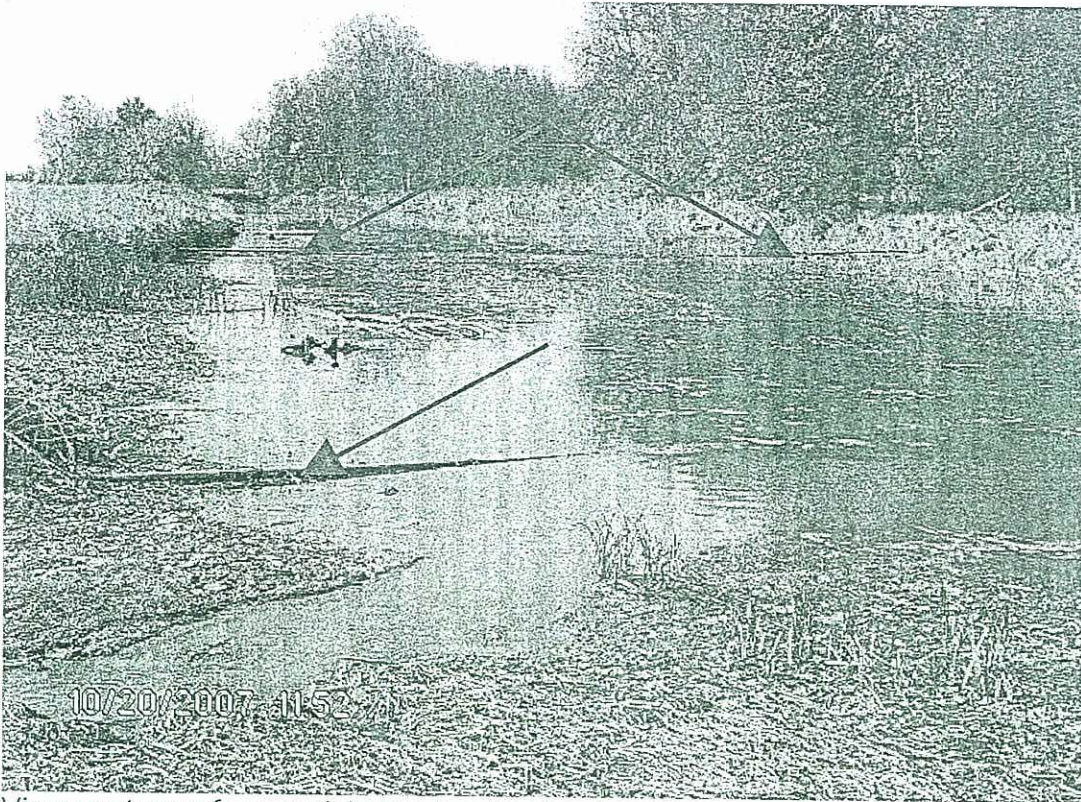
View upstream from park in Kawkawlin showing pipes spanning river.

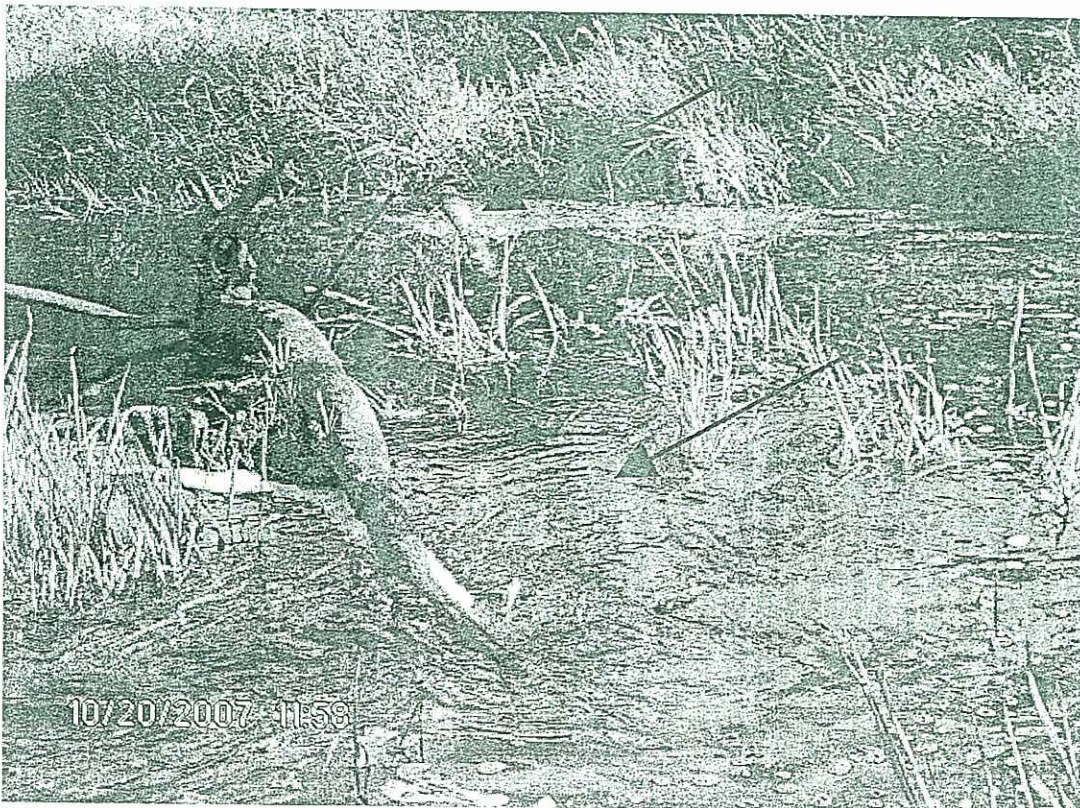
View of pipe spanning river about 10 yards downstream from Chip Rd. bridge, looking east.

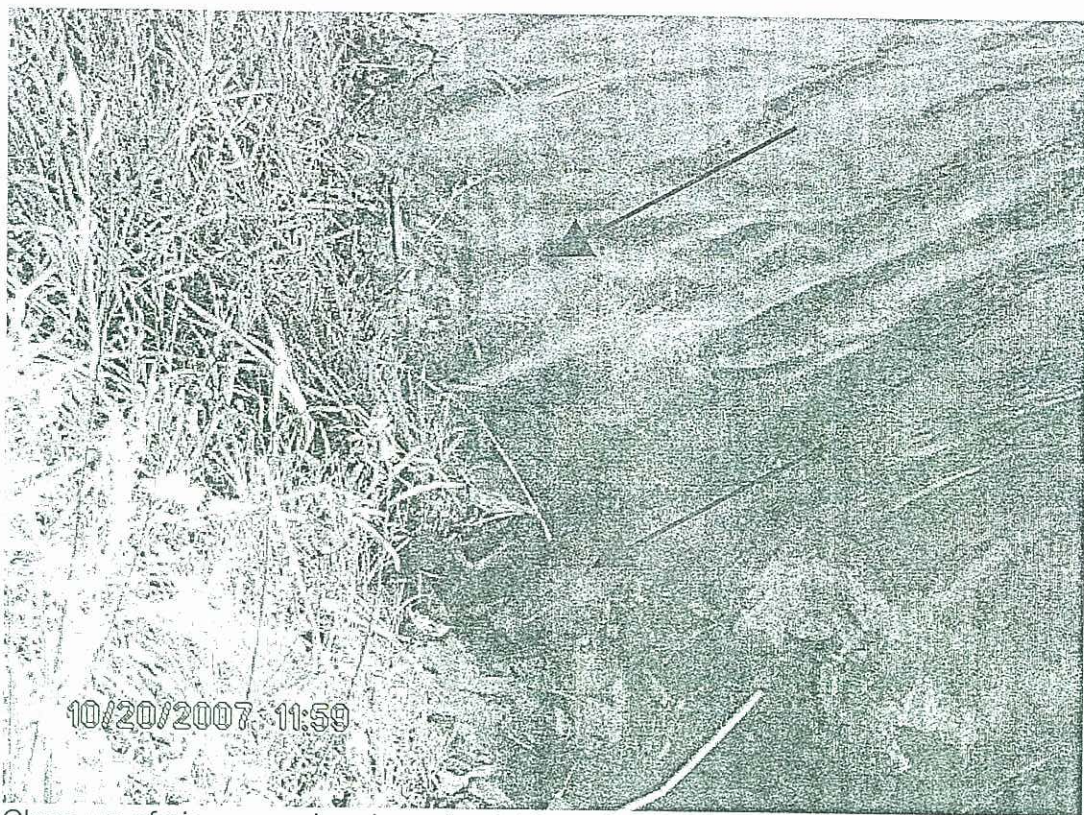
Close-up of pipe spanning river about 10 yards downstream from Chip Rd. bridge, on west bank.

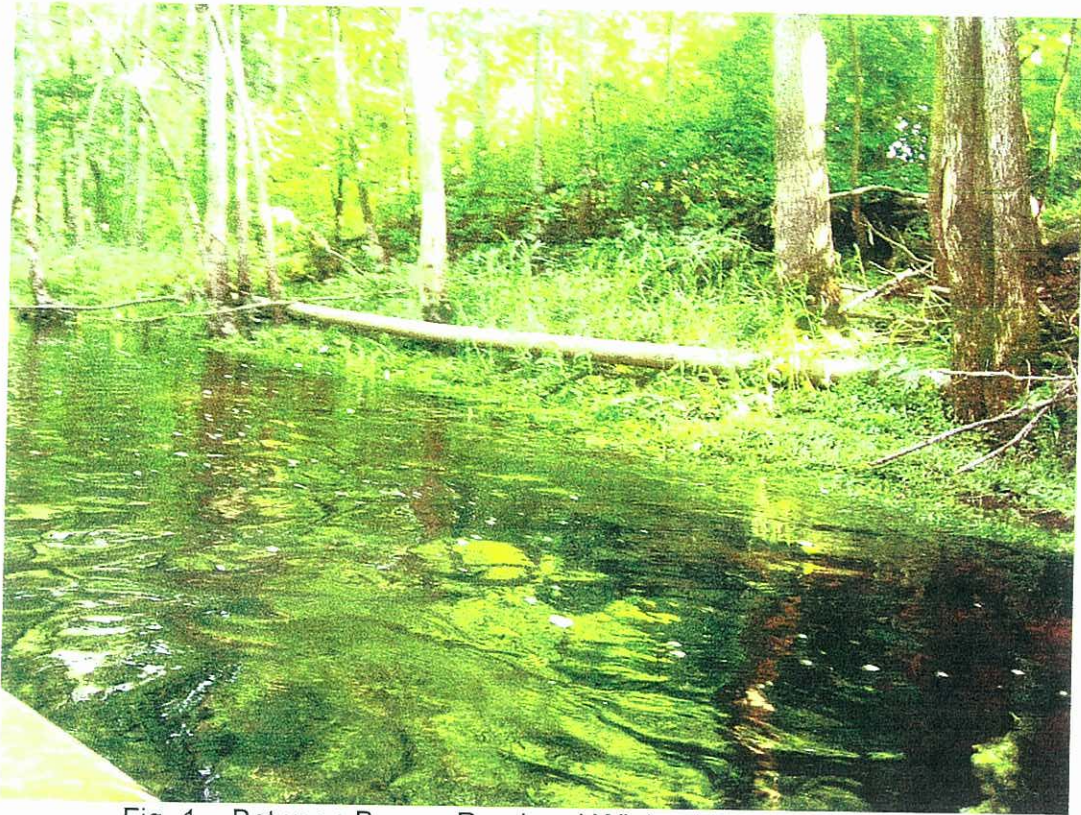
Fig. 1 – Between Beaver Road and Wieland Farm, West bank.

Attached are photos taken 06-22-2005 from my kayak along the North Branch of the Kawkawlin River. There are seven (7) photos total, labeled Fig. 1 – 7, showing the rusty old piping lying along the river banks. It is my assumption that this piping was originally used to pipe oil from the various small scavenger wells in the area to a central collection tank. If you can get the present owner of these wells to remove the piping, it will need to be done with care. They will need absorbent booms to contain any oil that might leak into the river. Their best bet would probably be to have Bierlein or a similar environmental cleanup company do the work to reduce the risk of a spill. Some expense will be involved, but at this point it's hard to feel sorry for any oil company, and they are ultimately responsible after all. If they won't cooperate willingly, maybe the DEQ will need to be brought in to encourage them to do the right thing. There must be many legal precedents assigning responsibility to the current owner for past sins (failure to cap abandoned wells, soil contamination, etc.).

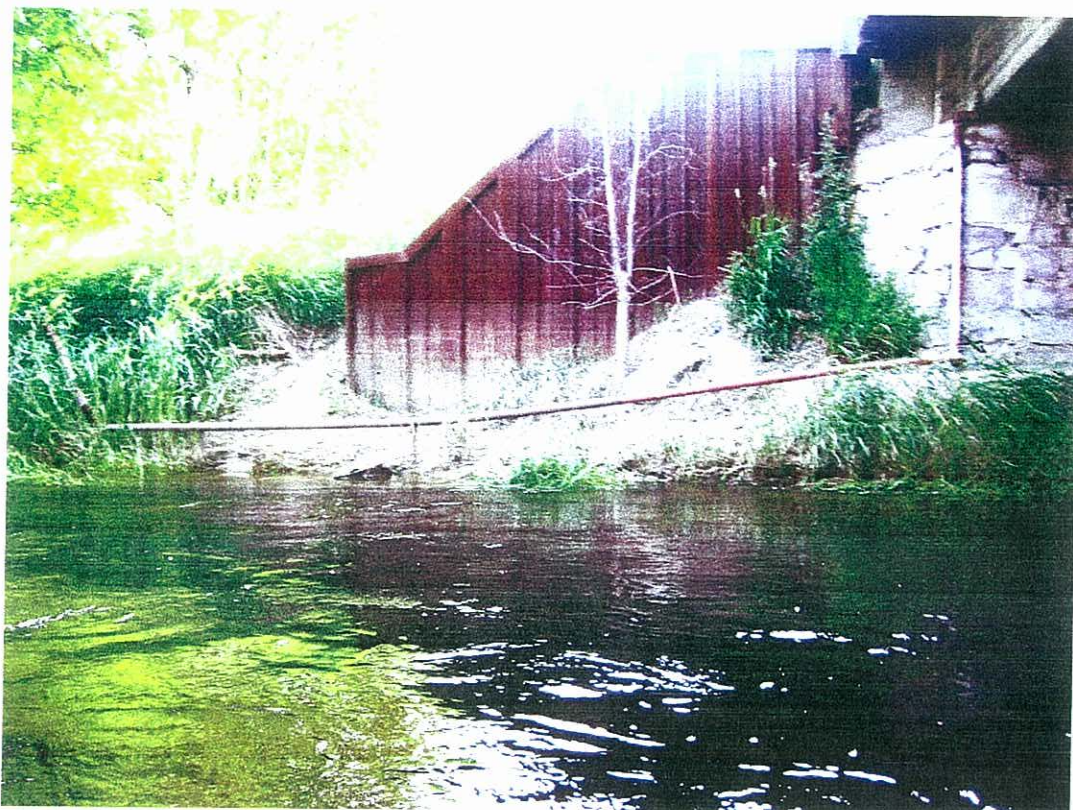
Fig. 3 – Under Chip Road Bridge.

Attached are files that I sent you back in early July... I think it's all there. Let me know if not. Seems to me if you stand on the Chip Road bridge and look downstream a few yards, there's another pipe laying across the river bottom that was not visible when I took these photos, along with the pictured pipes hanging under the bridge itself.
